5700A/AN Failure Analysis

Kevin Abercrombie
Naval Air Warfare Center, Aircraft Division
Patuxent River, MD

NCSLI Workshop & Symposium July 29 - August 2, 2001

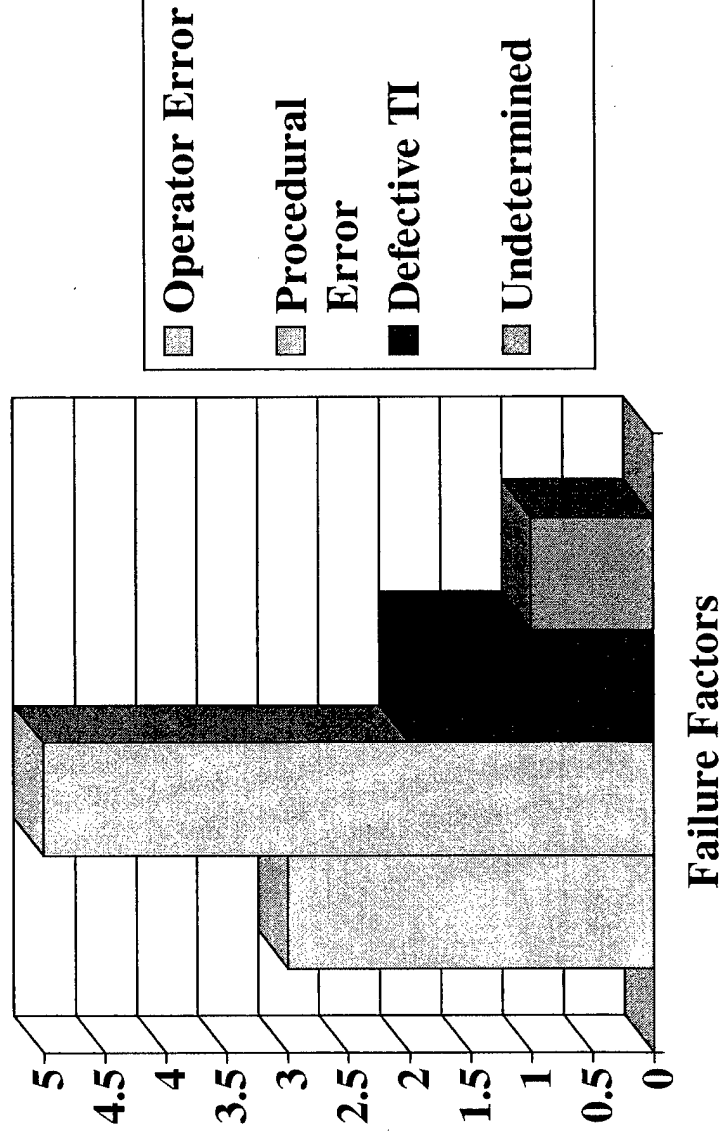
- Data Evaluation
 - In 4 of the 7 cases, more than one factor contributed to the failure.
